From: Commander, U. S. Naval Aviation Safety Center
To: Commanding Officer, Marine Fighter-Attack Squadron FIVE ONE THREE
Subj: VMFA-513 AAR ser 1-66A concerning F-4B BuNo 148404 accident
occurring 24 February 1966, pilot ZOBENICA

FIRST SUPPLEMENTARY REPORT on VMFA-513 AAR Serial 1-66A, 24 Feb 66,
F4B BuNo 148404, Pilot ZOBENICA

AV FORM 3750-1A (Rev. 3-63) Page

VMFA-513, Ser 1-66, 24 Feb 1966, F4B, BuNo 148404, Pilot ZOBENCICA

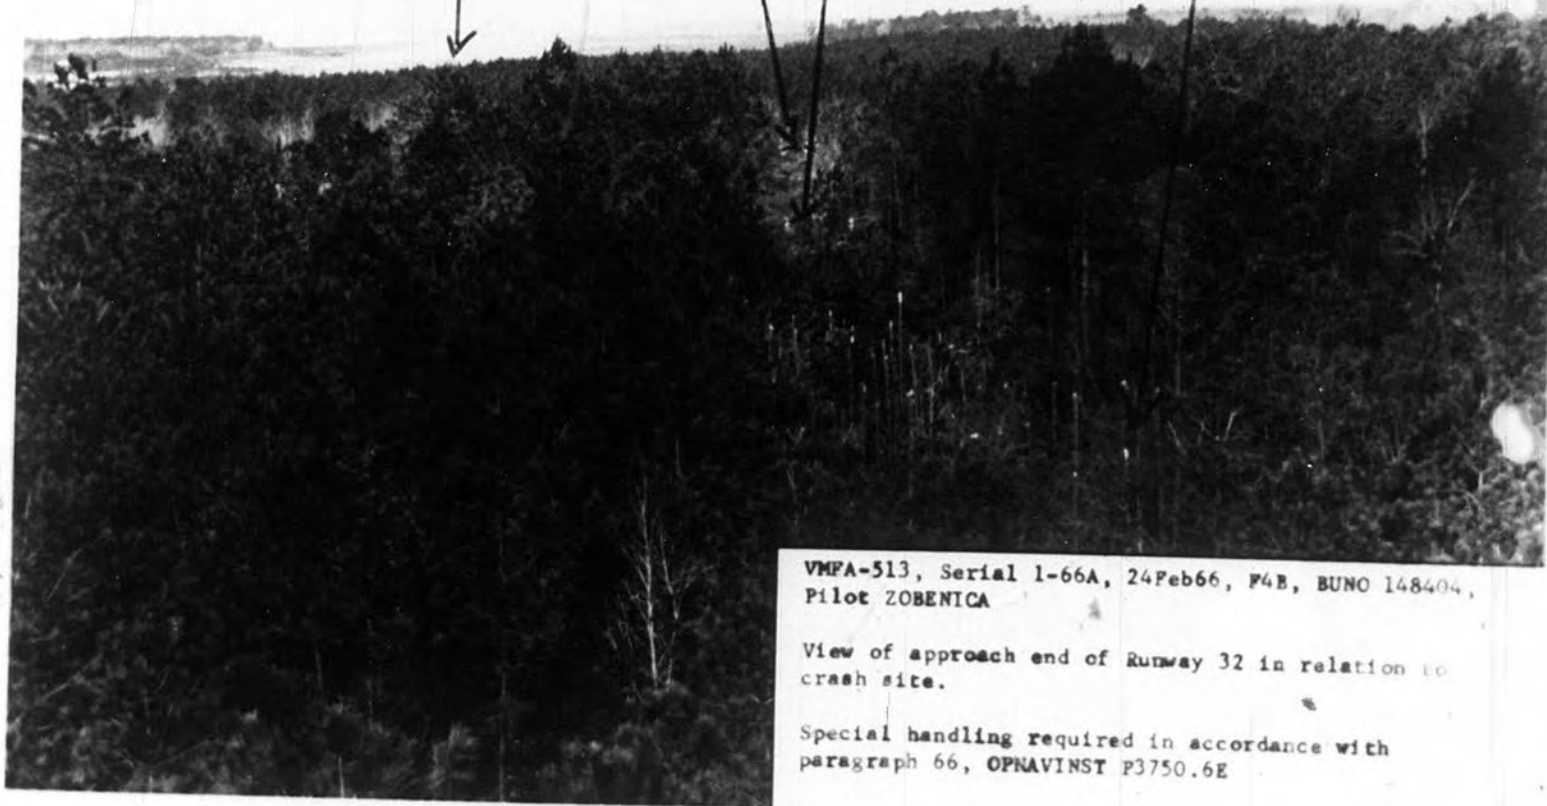
INITIAL IMPACT
WITH GROUND

INITIAL IMPACT
WITH TREES

View of approach end of Runway 32 in relation to
crash site.

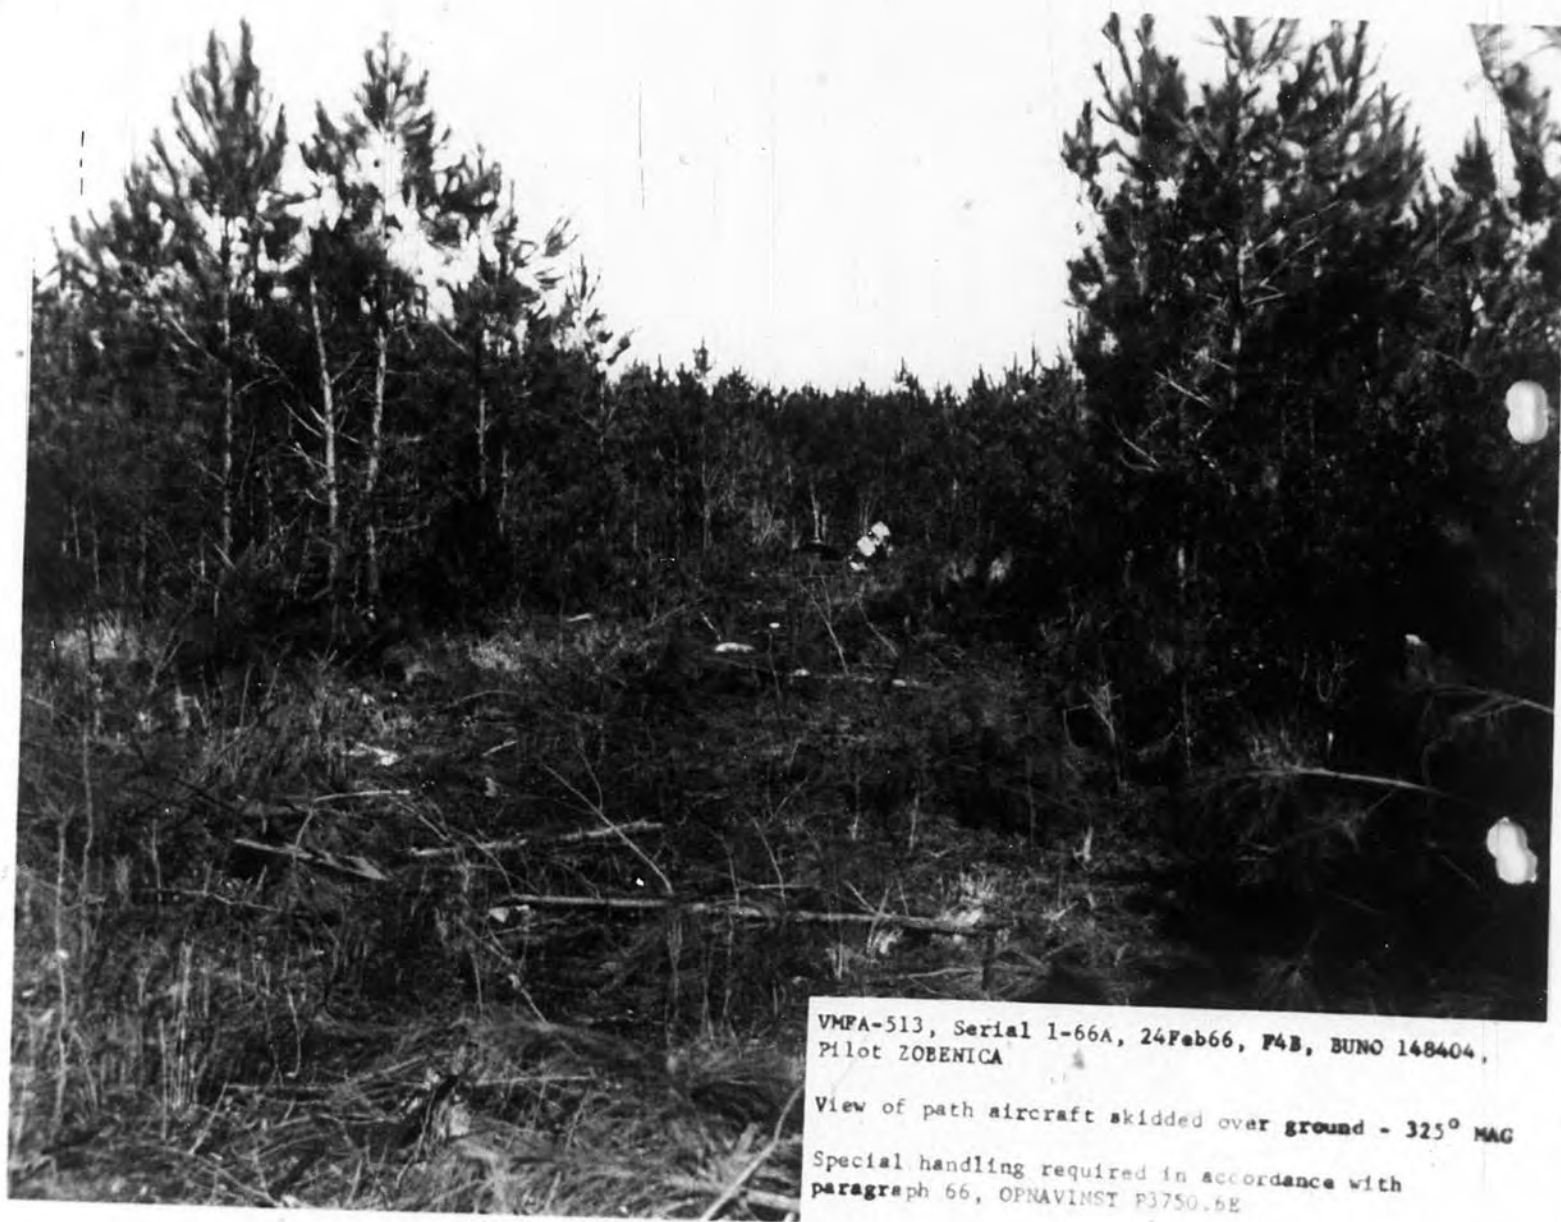
F4B BuNo 148404 sustained strike damage after sliding approximately 550 feet through trees and dense underbrush, finally coming to rest at the bottom of a slight draw.

View of path aircraft skidded over ground - 325° MAG

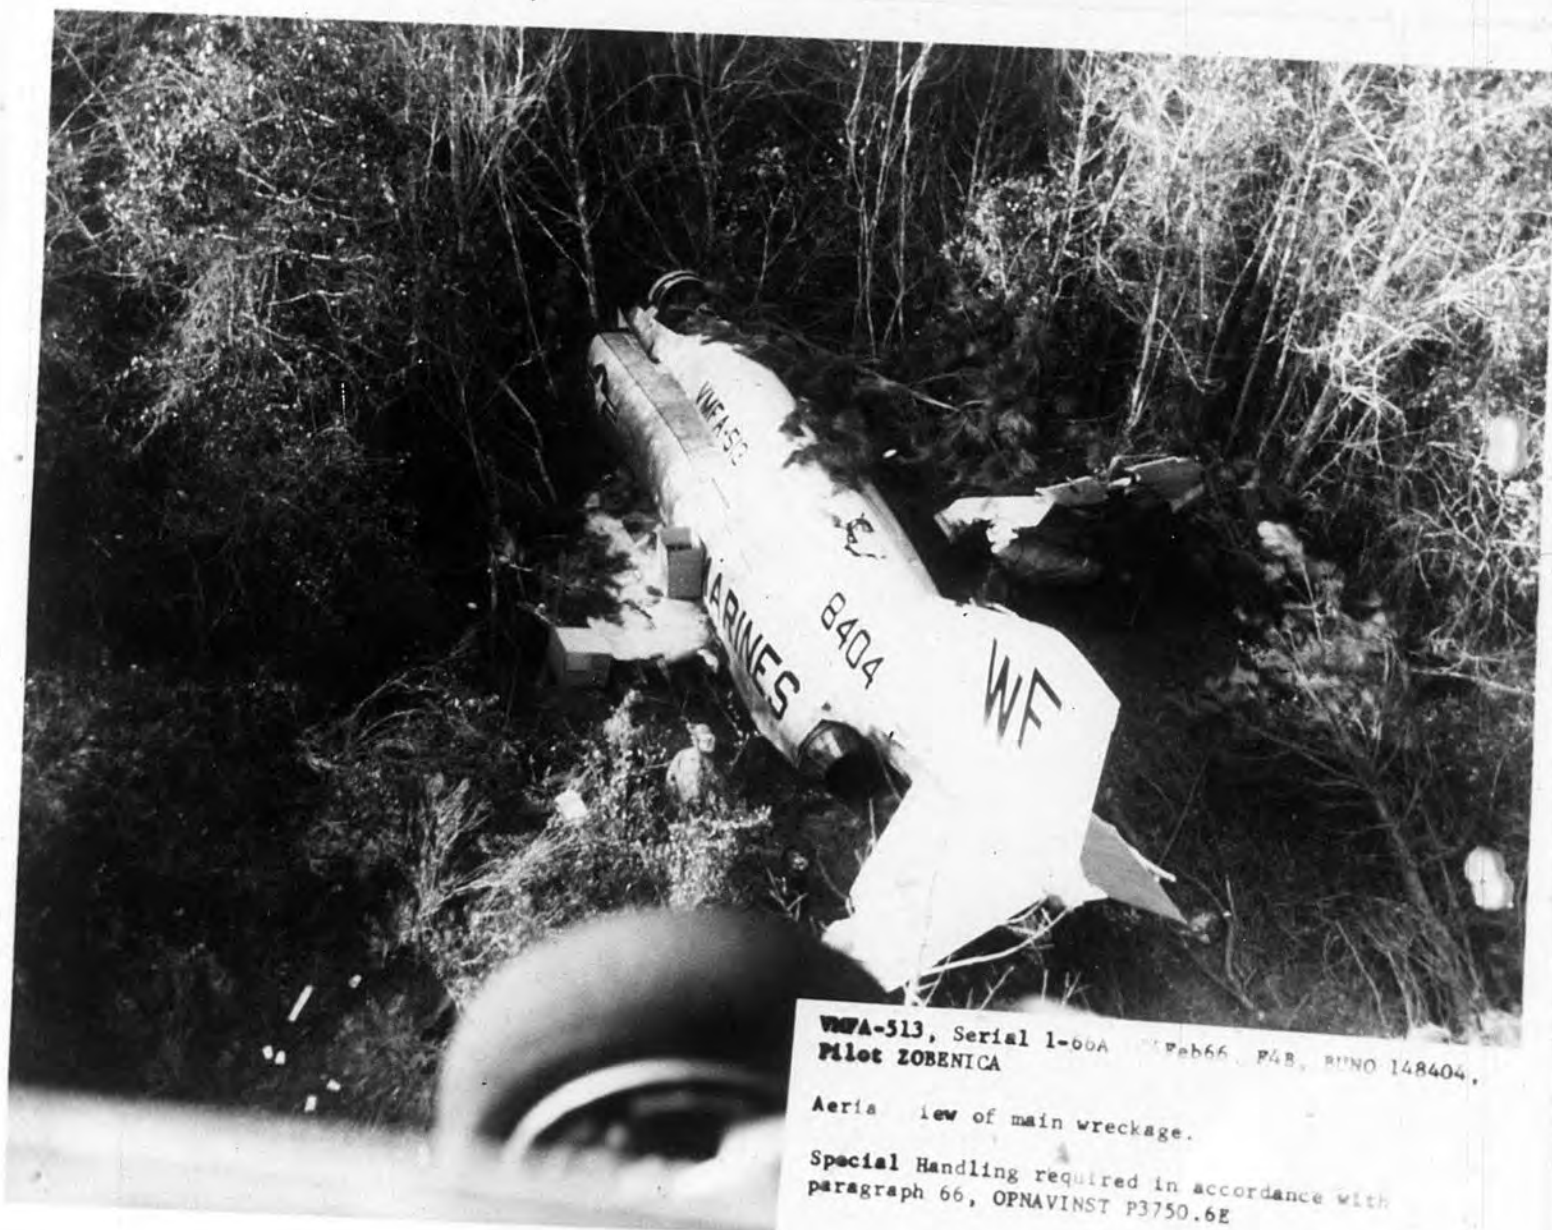
The aircraft came to rest with left side and complete front of pilots cockpit missing, a tree approximately 6-8 inches in diameter was wedged between left forward corner of seat and left console. The left console forward of the fuel control switches twisted outboard and straight back along side the left intake ramp. The right console was intact. The control stick was lying 90° to the left in front of pilot's seat with the grip broken in three places. The remaining fuselage section of the aircraft was imbedded in soft earth and water up to the leading edge of the pilots seat. The instrument panel was lying approximately 8-10 feet forward and slightly left of the front seat.

Aerial view of main wreckage.

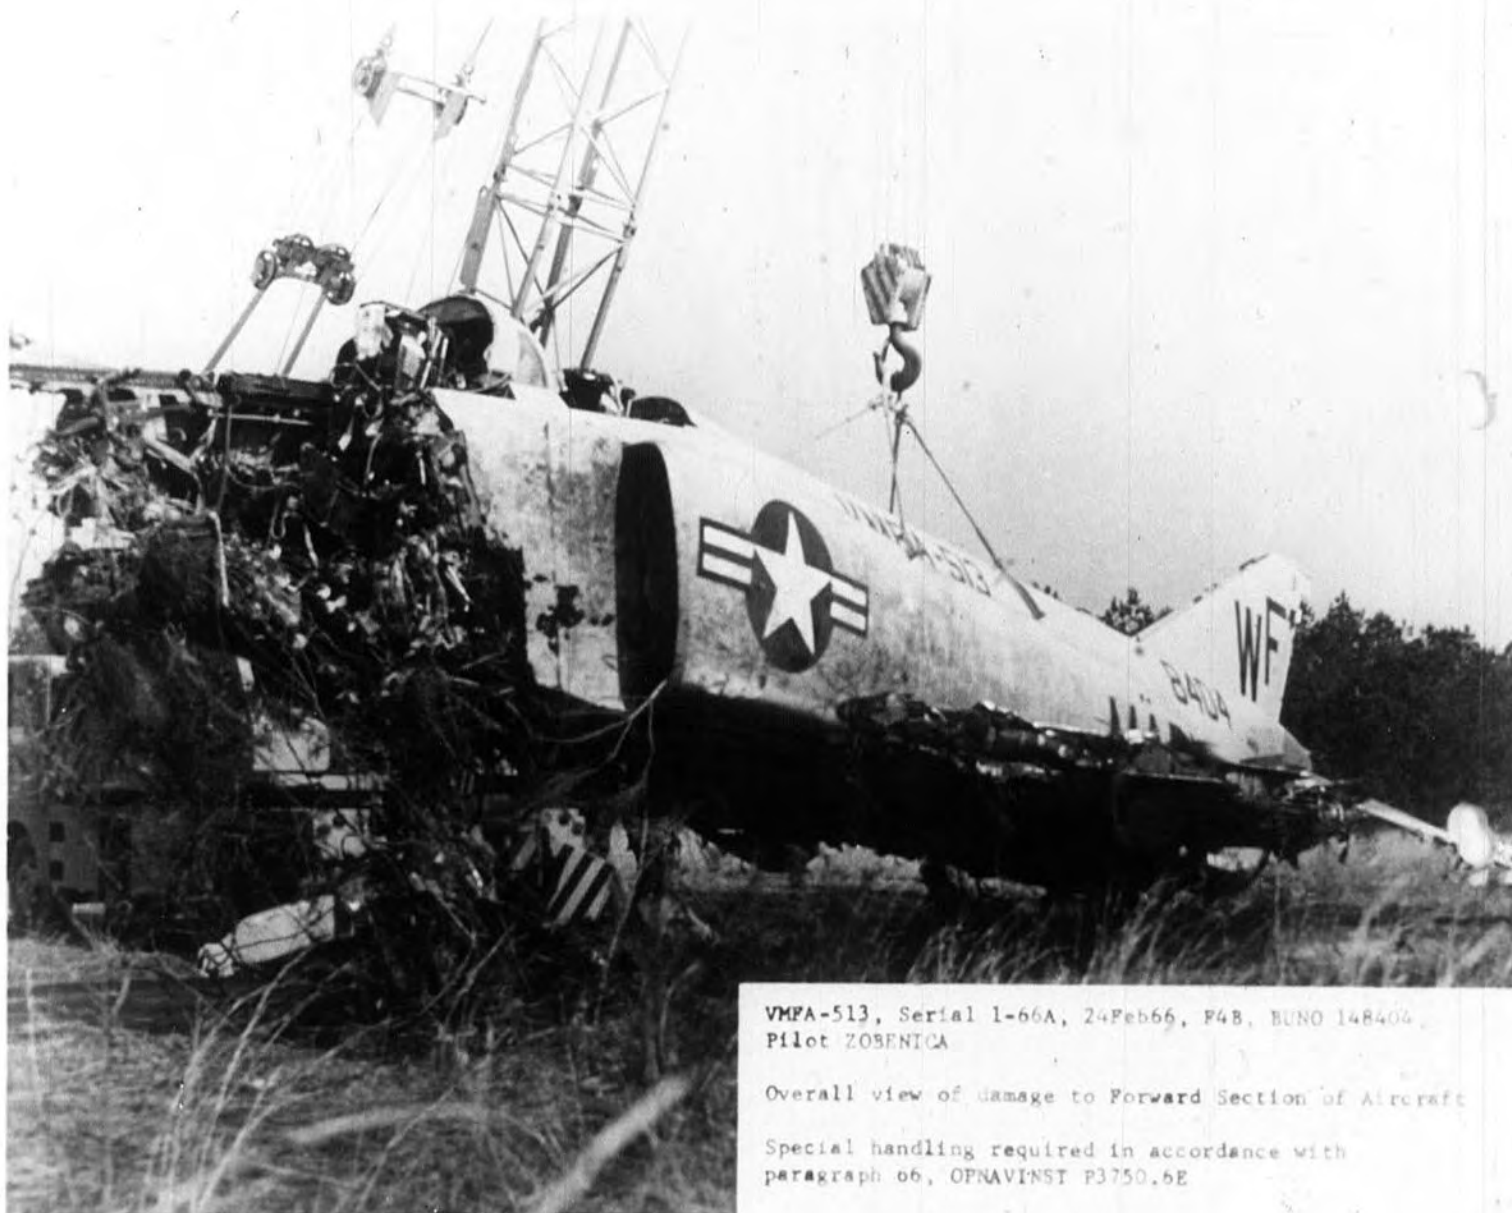
Overall view of damage to Forward Section of Aircraft

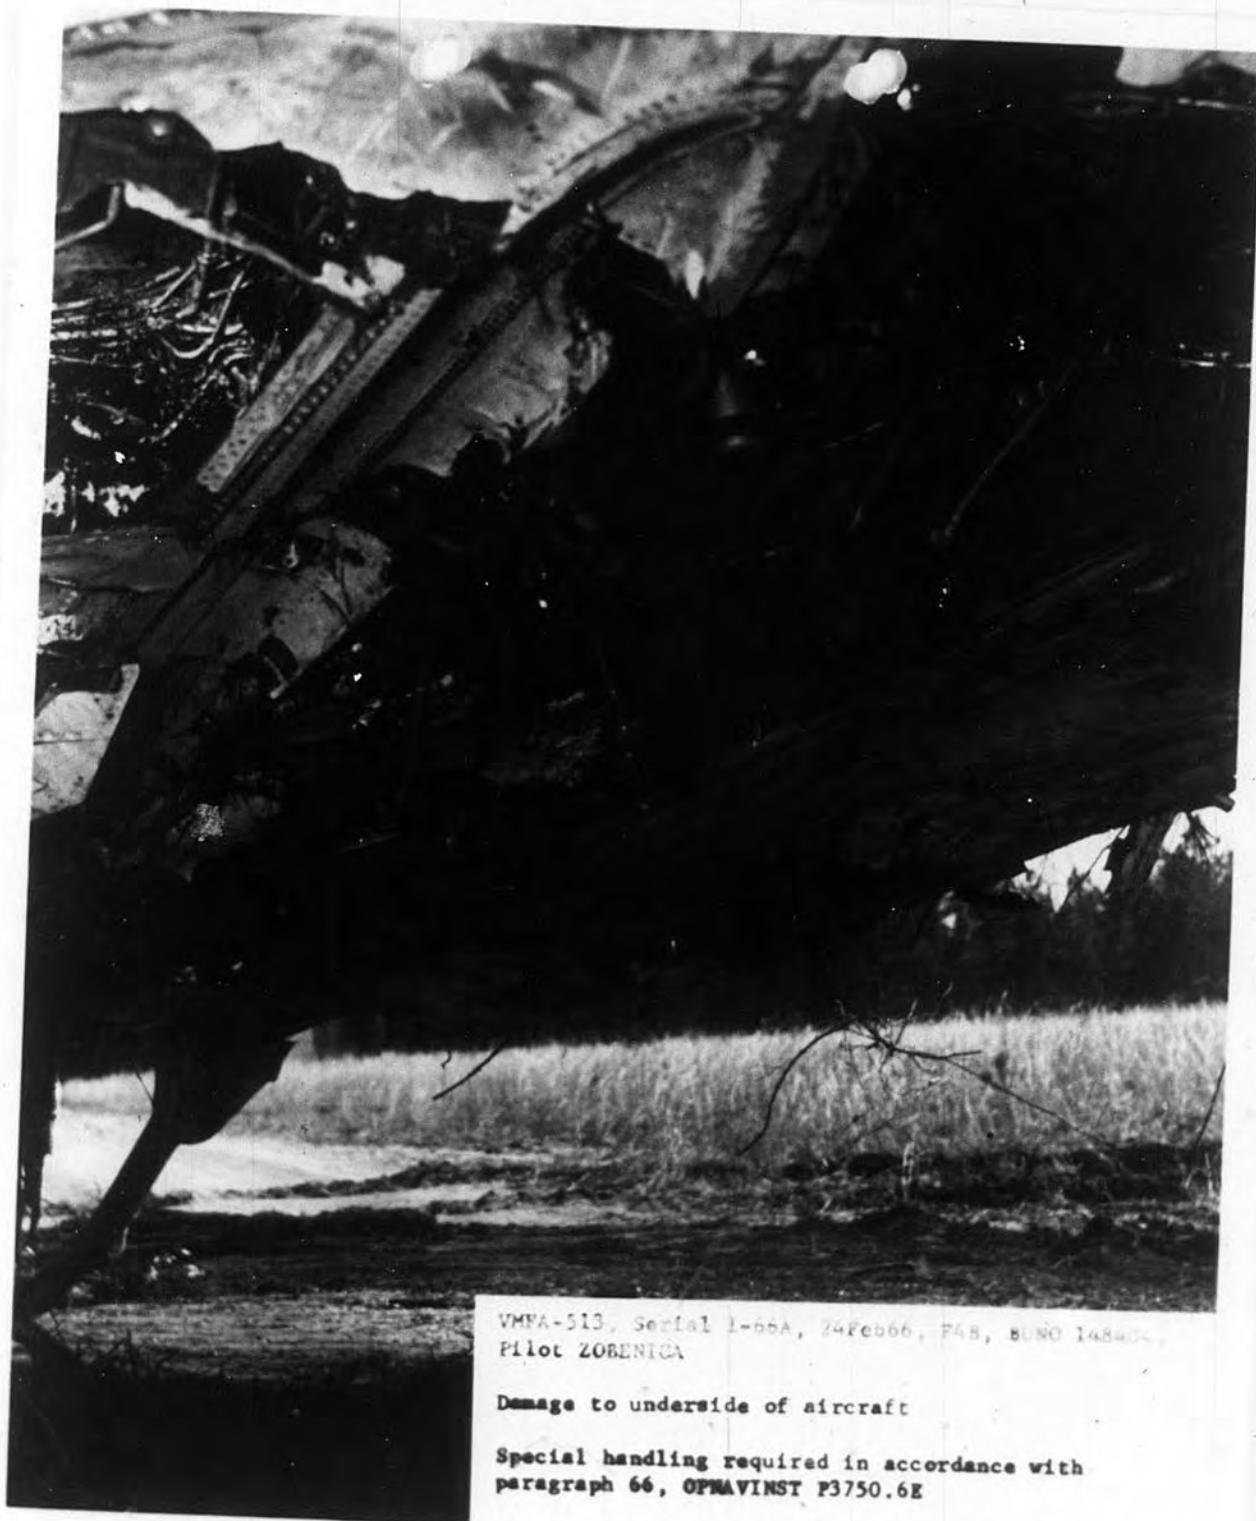
The aircraft sustained a large hole in the turtle back over the fifth and sixth fuel cells; also, a semi-circular dent 10 inches deep was in the center, leading edge, of the left stabilator. Evidence of ingested trees and dirt was found in the tail pipes of both engines.

Damage to underside of aircraft
